Town of Rowley

Bridge Inventory Evaluation

JUNE 2019

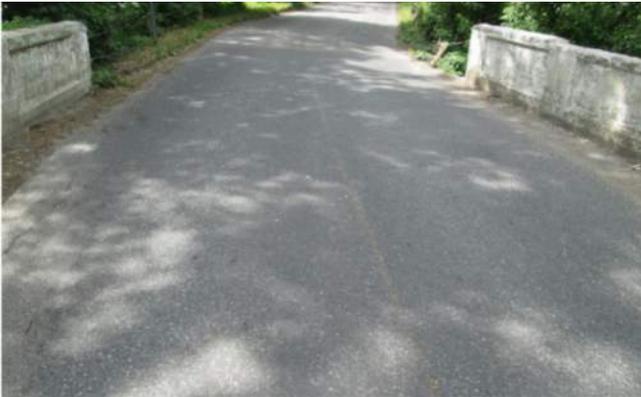
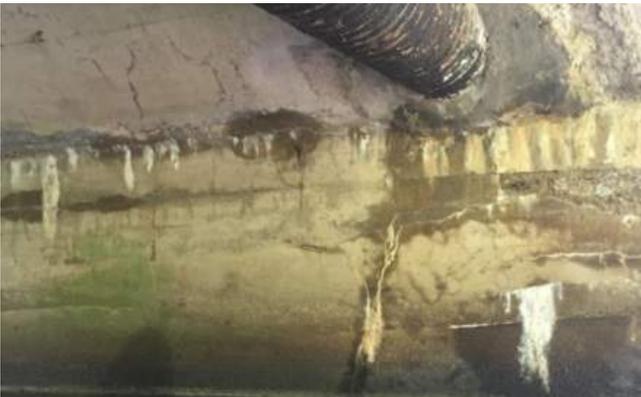
R-11-002 Glen Street over Mill River

BRIDGE TYPE Arch-deck with concrete

OVERALL CONDITION 4

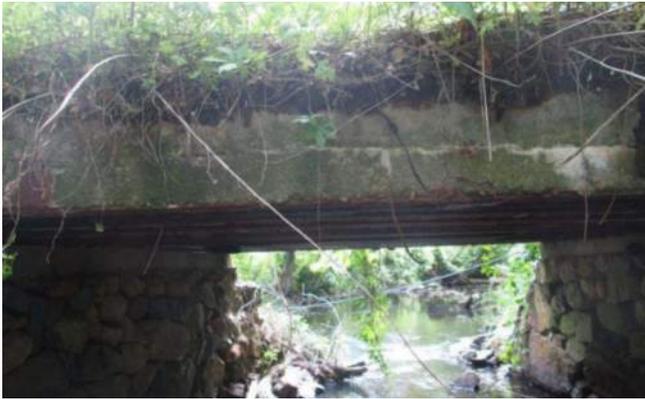
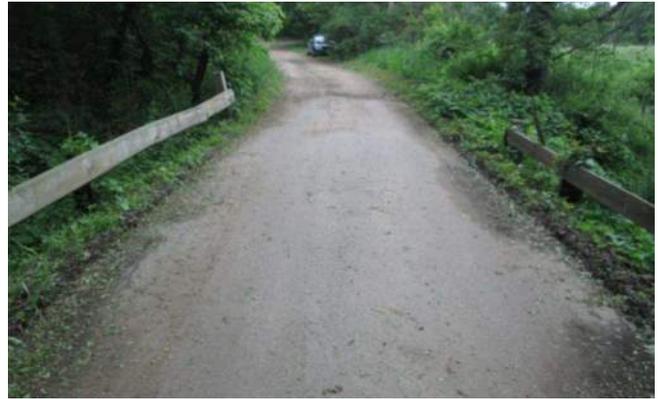
R-11-006
Mill Road over Mill River

BRIDGE TYPE Steel Girder

OVERALL CONDITION 4

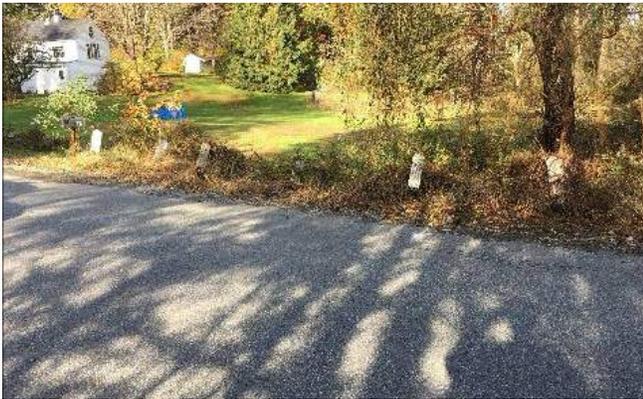
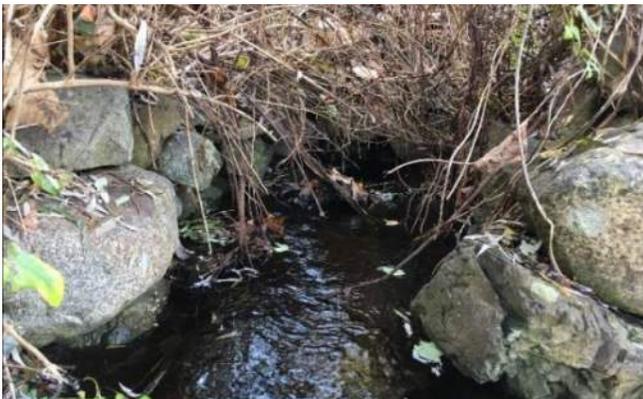
1. Bennett Hill Road (22)

BRIDGE TYPE	Single culvert–Stone
WEARING SURFACE	Asphalt
RAILING TYPE	
UPSTREAM	Wood
DOWNSTREAM	None
OVERALL CONDITION	6
NOTES:	Difficult access due to vegetation
IMMEDIATE NEEDS	Remove vegetation from channel

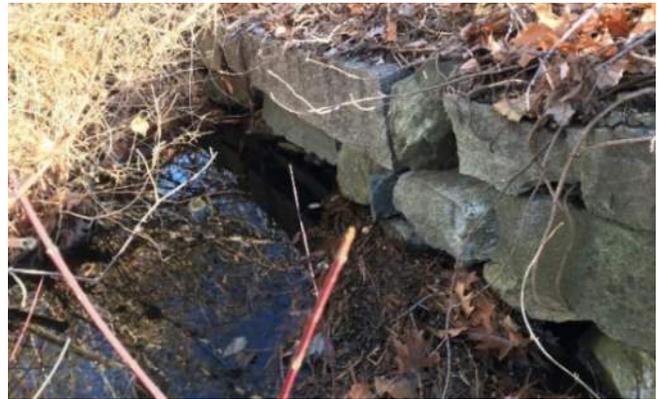
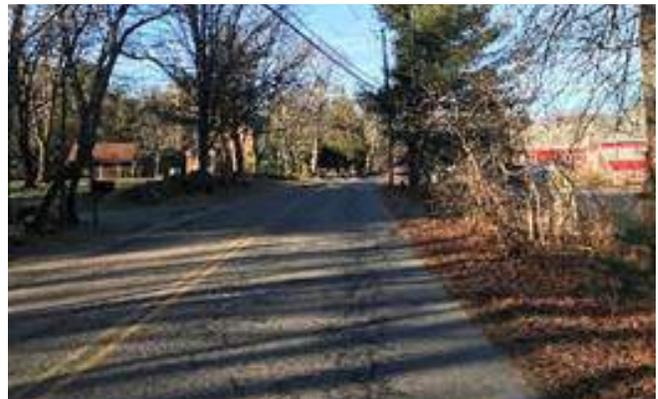
2. Boxford Road (38)

BRIDGE TYPE	Single culvert with metal pipe
WEARING SURFACE	Asphalt
RAILING TYPE	
UPSTREAM	None
DOWNSTREAM	None
OVERALL CONDITION	6
NOTES:	Clean culvert of sediment, and channel of debris and vegetation.
IMMEDIATE NEEDS	Culvert is almost full of sediment, dry laid stone headwalls satisfactory

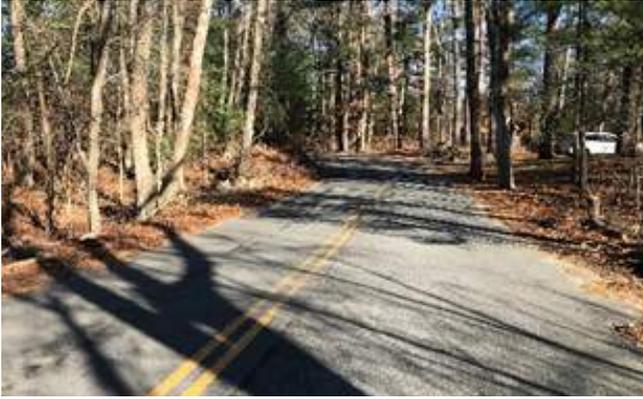
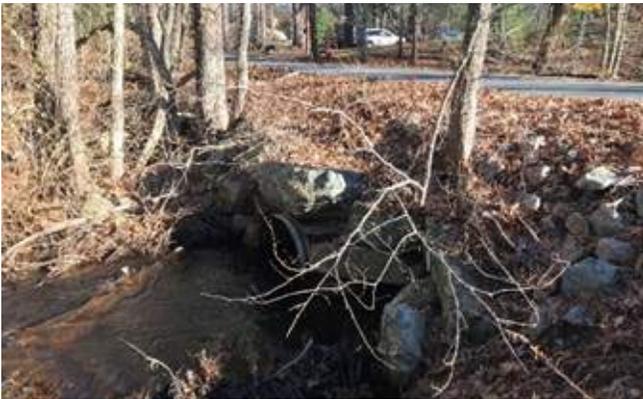
3. Boxford Road (238)

BRIDGE TYPE	Single culvert with metal pipe
WEARING SURFACE	Asphalt
RAILING TYPE	
UPSTREAM	None
DOWNSTREAM	None
OVERALL CONDITION	6
NOTES:	SDS headwall has 5" +/- tree growing on top. Both stone headwalls have loose or settled stones.
IMMEDIATE NEEDS	Clean debris from channel; remove tree at downstream headwall; rebuild both headwalls.

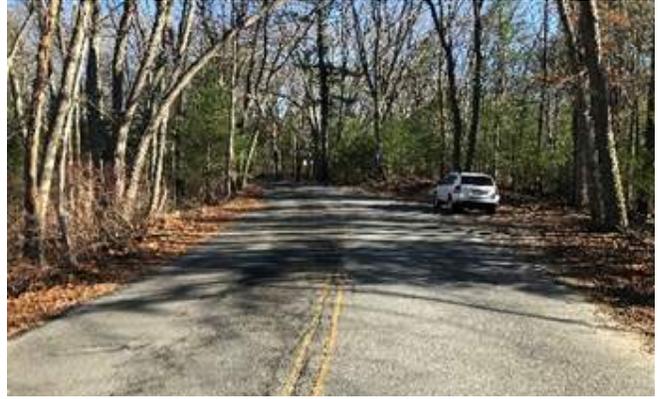
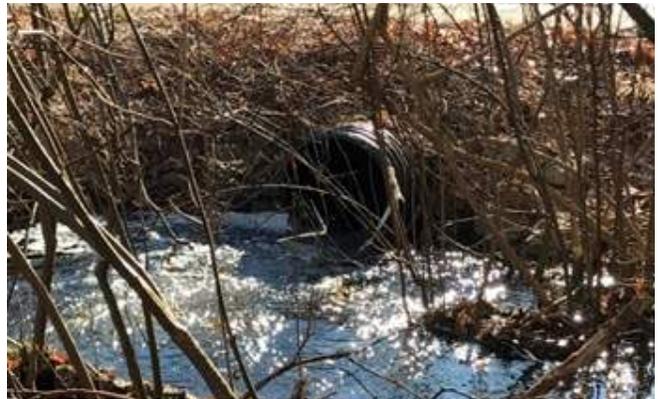
4. Boxford Road (326)

BRIDGE TYPE	Single culvert with poly pipe
WEARING SURFACE	Asphalt
RAILING TYPE	
UPSTREAM	None
DOWNSTREAM	None
OVERALL CONDITION	6
NOTES:	Plastic pipe is generally in a good condition, but damaged in upstream end. No headwalls. Loose stone laid on downstream end.
IMMEDIATE NEEDS	Clear vegetation and debris; monitor undermining at pipe ends.

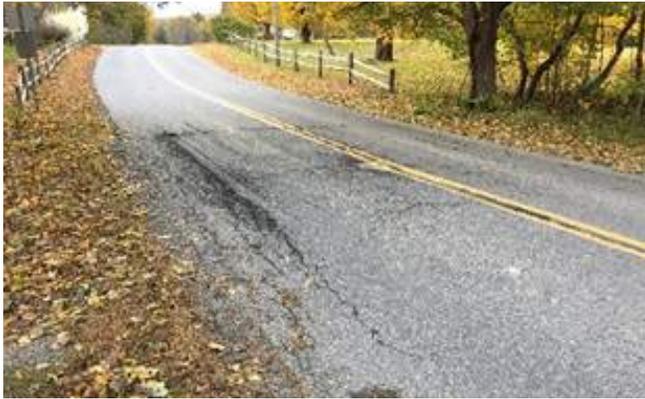
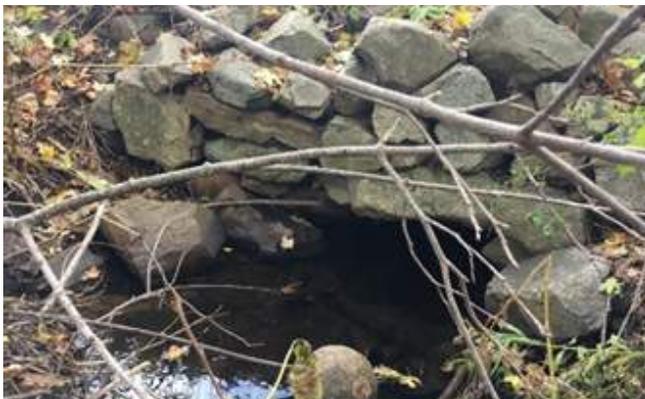
5. Bradford Street (53)

BRIDGE TYPE	Single culvert with clay pipe
WEARING SURFACE	Asphalt
RAILING TYPE	
UPSTREAM	Wood
DOWNSTREAM	None
OVERALL CONDITION	6
NOTES:	Un-grouted masonry headwall and channel outlet. Inlet headwall is failing (un-grouted stone). Pipe is half filled with sediment. Pavement is in poor condition.
IMMEDIATE NEEDS

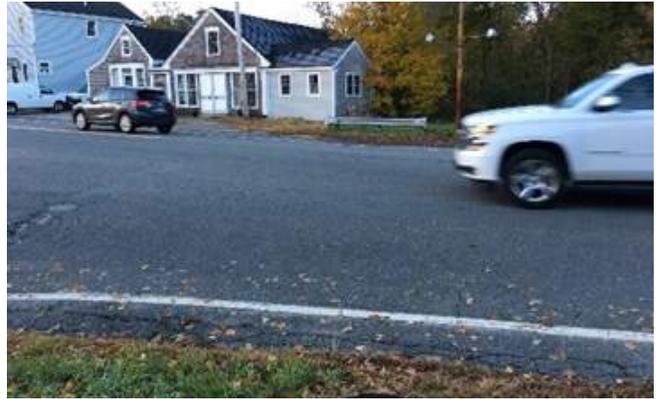
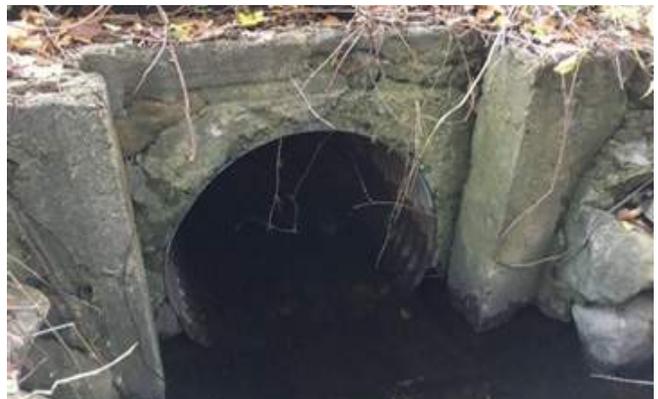
6. Central Street (23)

BRIDGE TYPE	Single Culvert with granite slabs/30" CMP at outlet
WEARING SURFACE	Asphalt
RAILING TYPE	
UPSTREAM	Guardrail
DOWNSTREAM	Wood
OVERALL CONDITION	6
NOTES:	Rusting and section loss at inlet. Partial collapsing of outlet headwall (missing stones). Flooding issues due to heavy rain.
IMMEDIATE NEEDS

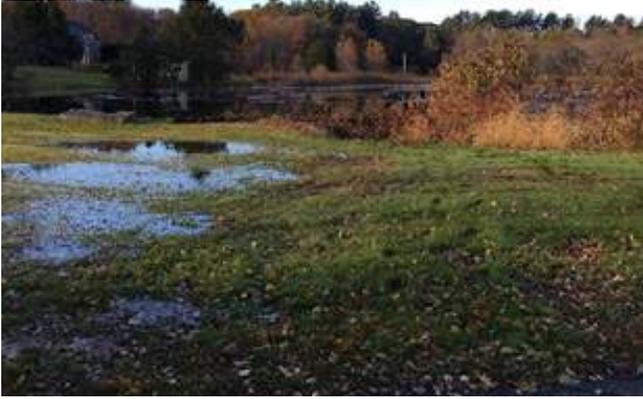
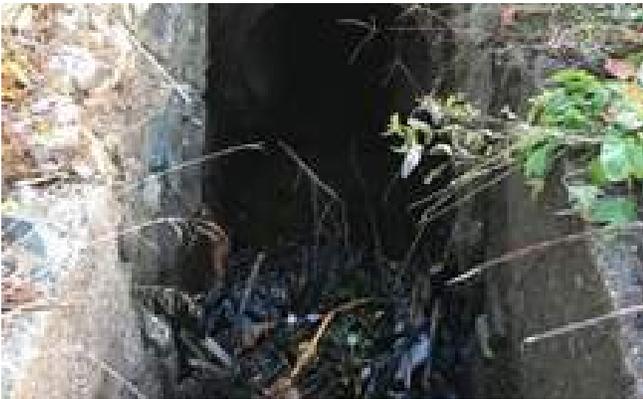
7. Central Street (151)

BRIDGE TYPE	Single culvert with concrete pipe
WEARING SURFACE	Asphalt
RAILING TYPE	
UPSTREAM	None
DOWNSTREAM	Wood
OVERALL CONDITION	5
NOTES:	Headwall at outlet is leaning. Inlet at pond on private property.
IMMEDIATE NEEDS	Grout stones at outlet headwall. Remove debris.

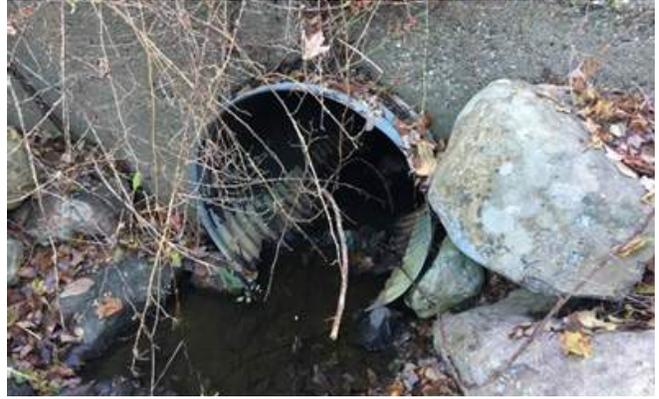
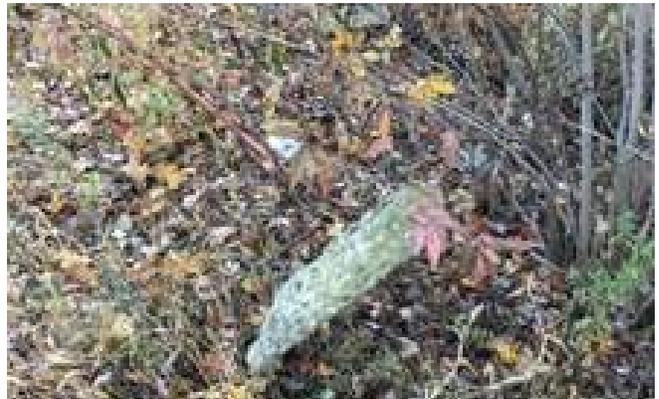
8. Central Street (293)

BRIDGE TYPE	Single culvert with metal pipe
WEARING SURFACE	Asphalt
RAILING TYPE	
UPSTREAM	None
DOWNSTREAM	None
OVERALL CONDITION	6
NOTES:	Corrosion and section loss for first 5' of pipe. Headwalls are concrete.
IMMEDIATE NEEDS

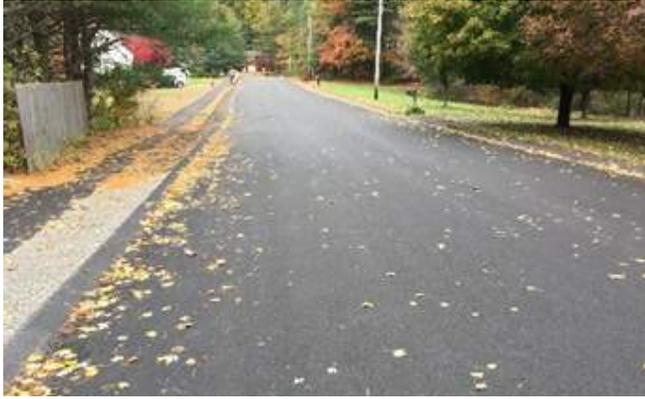
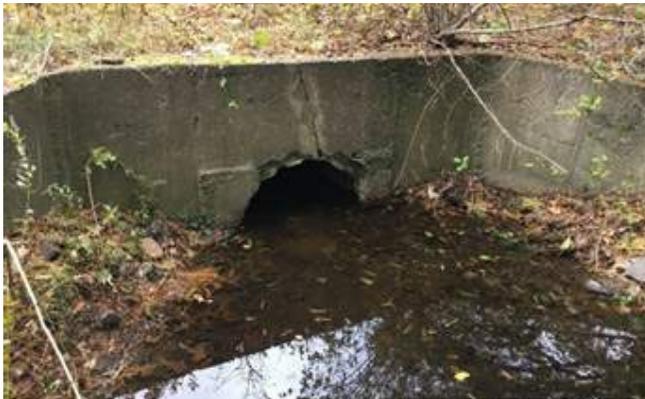
9. Christopher Road (47)

BRIDGE TYPE	Single culvert with metal pipe
WEARING SURFACE	Asphalt
RAILING TYPE	
UPSTREAM	None
DOWNSTREAM	None
OVERALL CONDITION	7
NOTES:	Vertical crack appears in downstream headwall. Inlet is on private property.
IMMEDIATE NEEDS

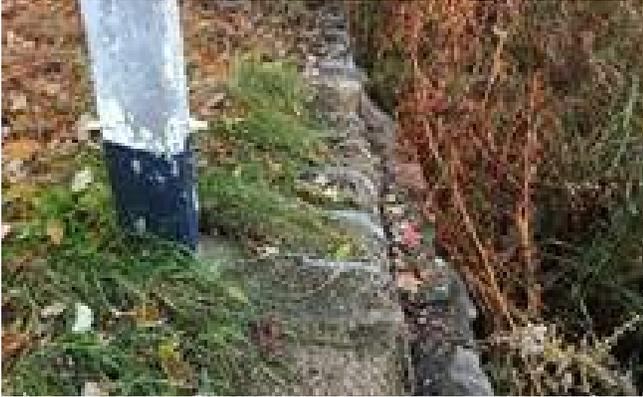
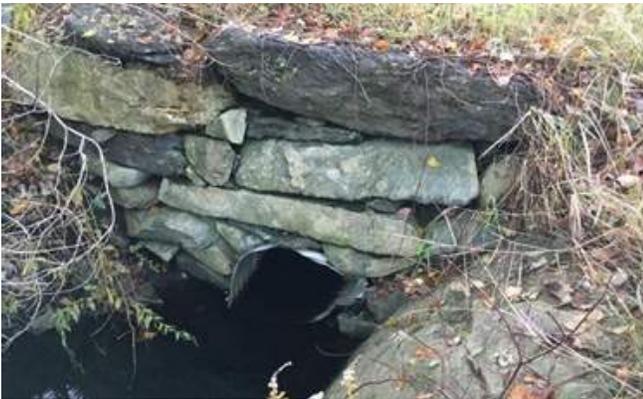
11. Cross Street (84)

BRIDGE TYPE	Single culvert with metal pipe
WEARING SURFACE	Asphalt
RAILING TYPE	
UPSTREAM	None
DOWNSTREAM	None
OVERALL CONDITION	6
NOTES:	Some crushing of pipe appears at outlet (could have been at construction). Grouted masonry appears at inlet; dry stacked masonry appears at outlet.
IMMEDIATE NEEDS

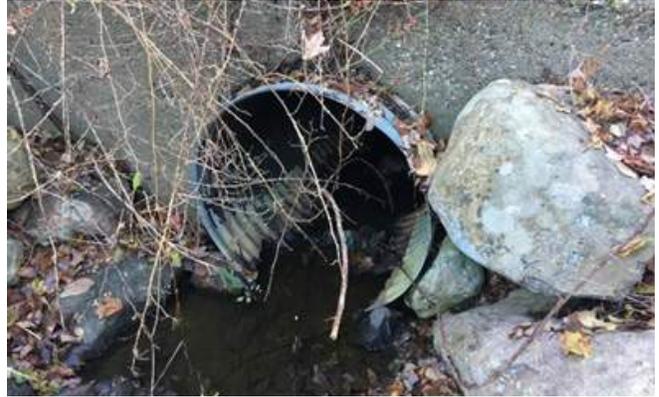
12. Daniels Road (25)

BRIDGE TYPE	Single culvert with metal pipe
WEARING SURFACE	Asphalt
RAILING TYPE	
UPSTREAM	None
DOWNSTREAM	Wood
OVERALL CONDITION	5
NOTES:	Bank erosion appears at downstream. Downstream headwall and wingwall appear to have collapsed.
IMMEDIATE NEEDS	Rebuild downstream headwall and wingwall.

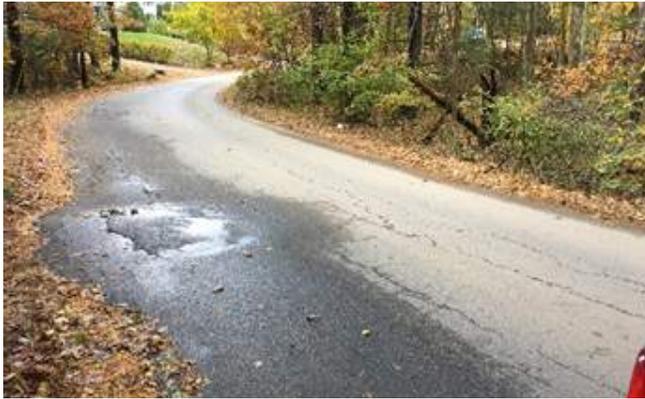
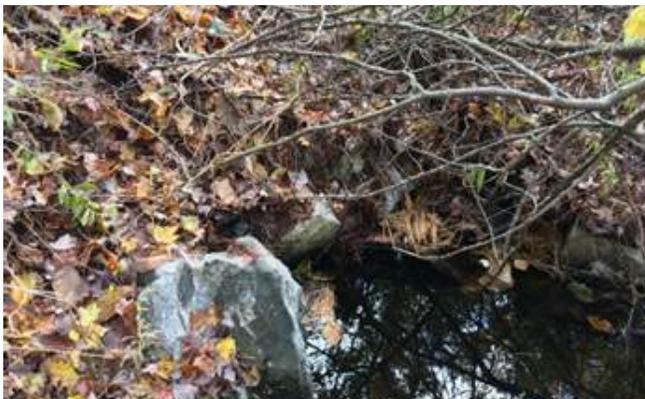
13. Dodge Road (22)

BRIDGE TYPE	Single culvert with clay pipe
WEARING SURFACE	Asphalt
RAILING TYPE	
UPSTREAM	None
DOWNSTREAM	None
OVERALL CONDITION	3
NOTES:	Appears headwall, wingwalls, and pipe have collapsed at outlet. Depression occurs in road above pipe.
IMMEDIATE NEEDS	Replace

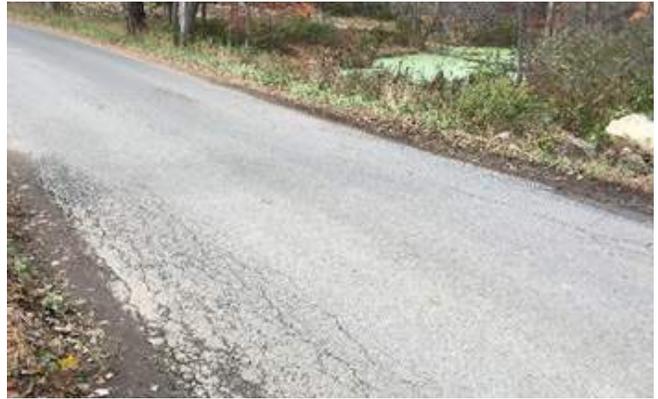
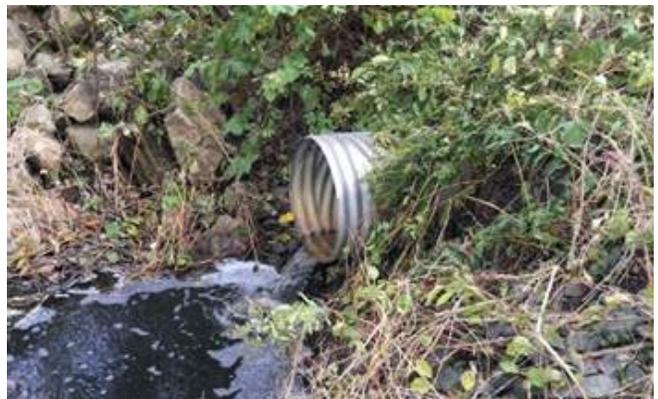
14. Dodge Road (77)

BRIDGE TYPE	Single culvert with metal pipe
WEARING SURFACE	Asphalt
RAILING TYPE	
UPSTREAM	None
DOWNSTREAM	None
OVERALL CONDITION	7
NOTES:	Riprap slope at inlet, perched outlet. Minor erosion of outlet bank.
IMMEDIATE NEEDS

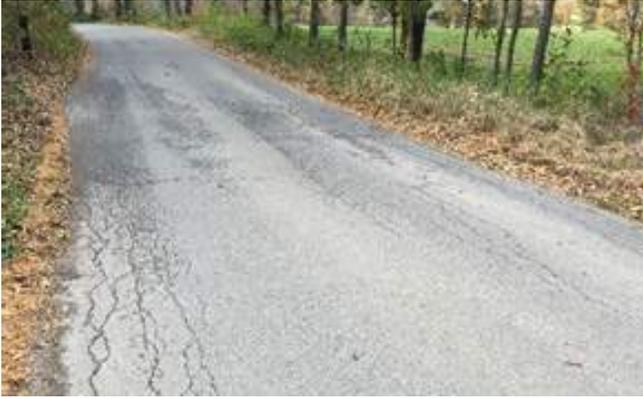
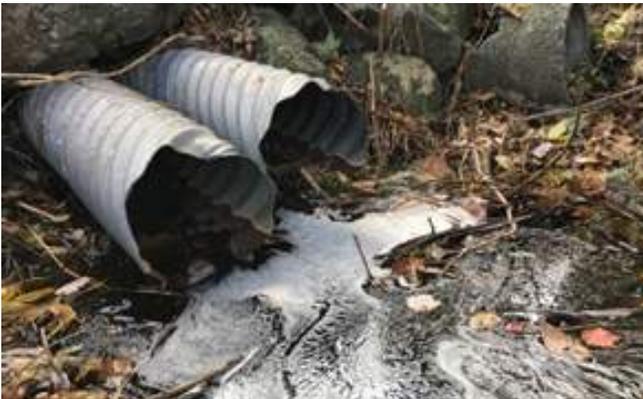
15. Dodge Road (149)

BRIDGE TYPE	Double culvert with metal pipe
WEARING SURFACE	Asphalt
RAILING TYPE	
UPSTREAM	None
DOWNSTREAM	None
OVERALL CONDITION	5
NOTES:	Gaps in stones at inlet and outlet. Perched outlet, bottom of pipe with 100% section loss for approx. 3' (water does not flow out end of pipe)
IMMEDIATE NEEDS

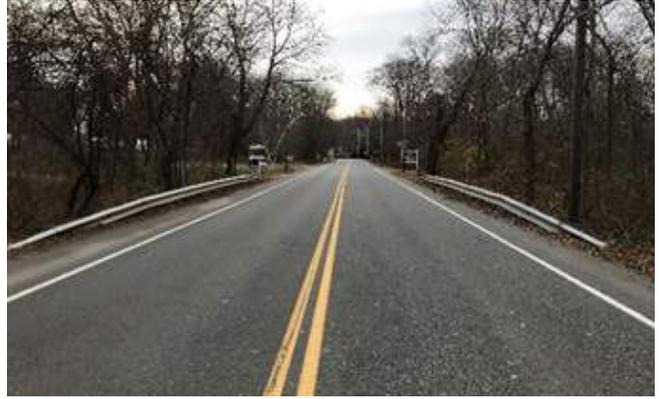
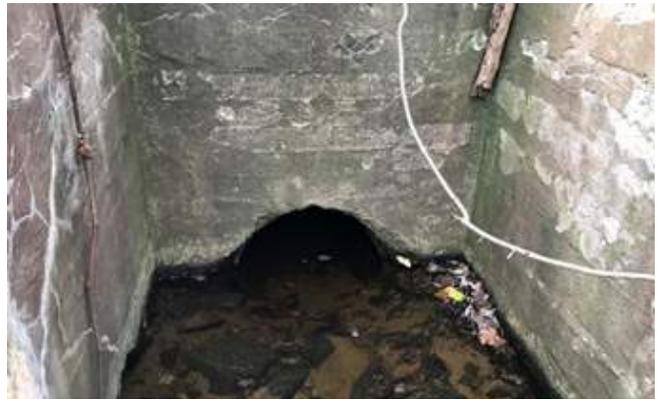
18. Haverhill Street (43)

BRIDGE TYPE	Single culvert with metal pipe
WEARING SURFACE	Asphalt
RAILING TYPE	
UPSTREAM	Metal guardrail
DOWNSTREAM	Metal guardrail
OVERALL CONDITION	5
NOTES:	Downstream end of pipe is rusted with minor section loss. Wingwalls are spalled and cracked. Upstream pipe is not visible. Headwall condition is poor with spalling and sink hole behind.
IMMEDIATE NEEDS	Rebuild upstream headwall

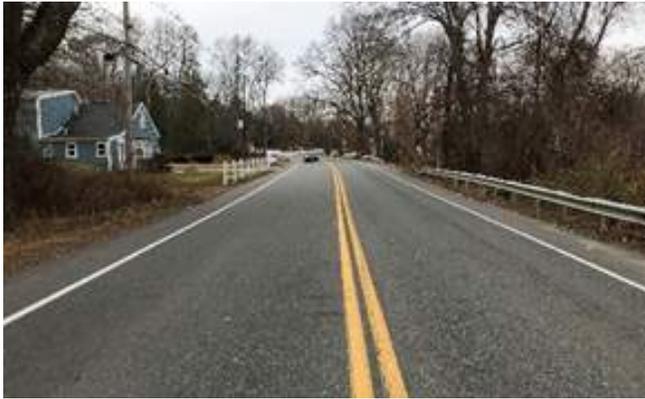
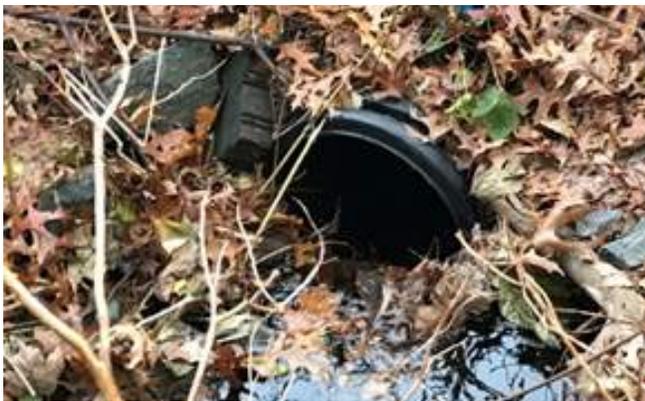
19. Haverhill Street (62)

BRIDGE TYPE	Single culvert with HDPE pipe
WEARING SURFACE	Asphalt
RAILING TYPE	
UPSTREAM	Metal guardrail
DOWNSTREAM	None
OVERALL CONDITION	6
NOTES:	Pipe is in a good condition. Downstream stone headwall is in a good condition. Concrete upstream headwall has some spalling.
IMMEDIATE NEEDS	Clean debris at portals.

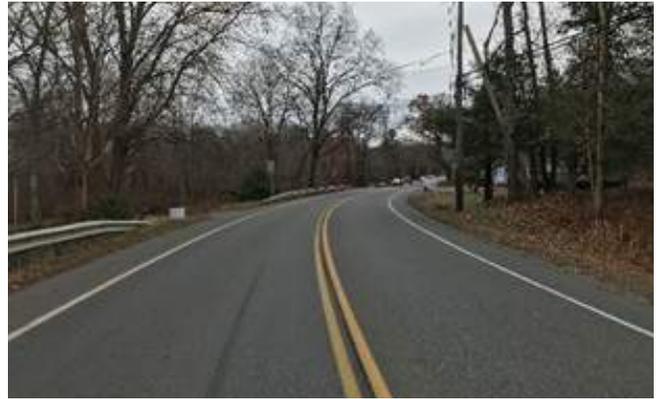
20. Haverhill Street (89)

BRIDGE TYPE	Single culvert with metal pipe (downstream) and plastic pipe (upstream)
WEARING SURFACE	Asphalt
RAILING TYPE	
UPSTREAM	Metal guardrail
DOWNSTREAM	None
OVERALL CONDITION	5
NOTES:	Upstream headwall in fair condition with some spalling. Roadway drains directly over headwall. Downstream headwall has minor spalling.
IMMEDIATE NEEDS	Repair upstream headwall

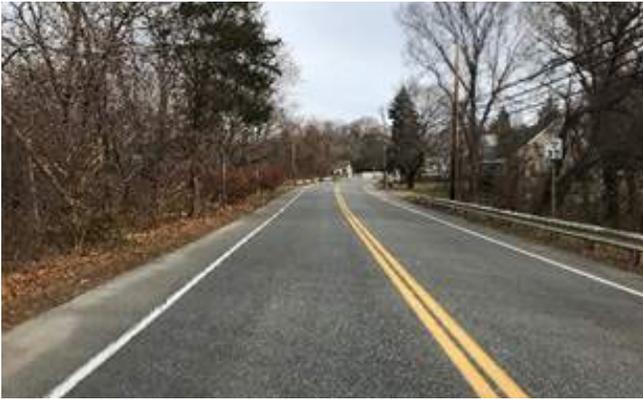
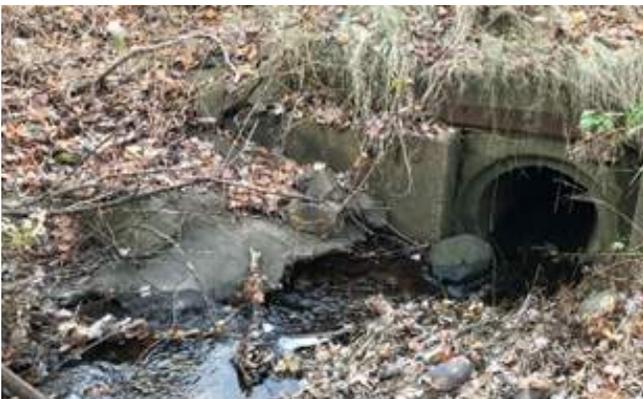
21. Haverhill Street (223)

BRIDGE TYPE	Single culvert with concrete
WEARING SURFACE	Asphalt
RAILING TYPE	
UPSTREAM	Metal guardrail
DOWNSTREAM	None
OVERALL CONDITION	4
NOTES:	Upstream headwall is in a good condition. Downstream headwall has failed.
IMMEDIATE NEEDS	Rebuild downstream headwall.

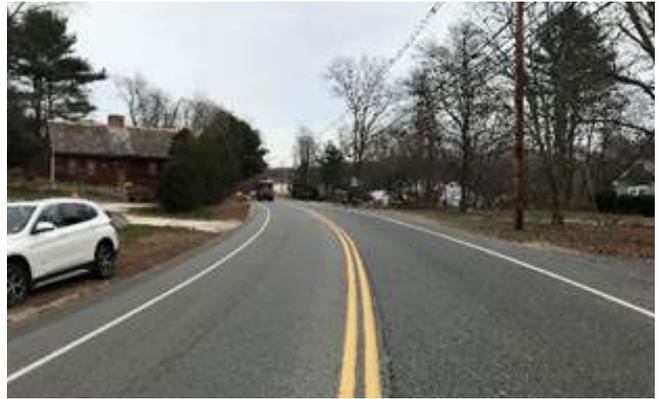
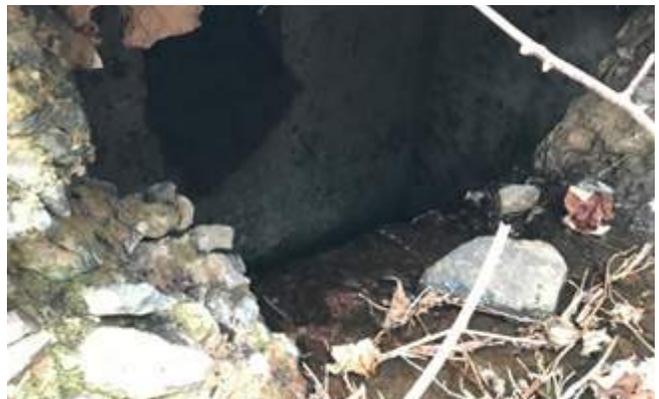
22. Haverhill Street (112)

BRIDGE TYPE	Single culvert with metal pipe
WEARING SURFACE	Asphalt
RAILING TYPE	
UPSTREAM	None
DOWNSTREAM	None
OVERALL CONDITION	
NOTES:	Upstream (N) is very heavily vegetated. Access is limited to obtain info on the culvert. Channel appears to drop upon entering upstream. Could not find downstream portal.
IMMEDIATE NEEDS	Clear vegetation up stream for better access. Scope upstream portal.

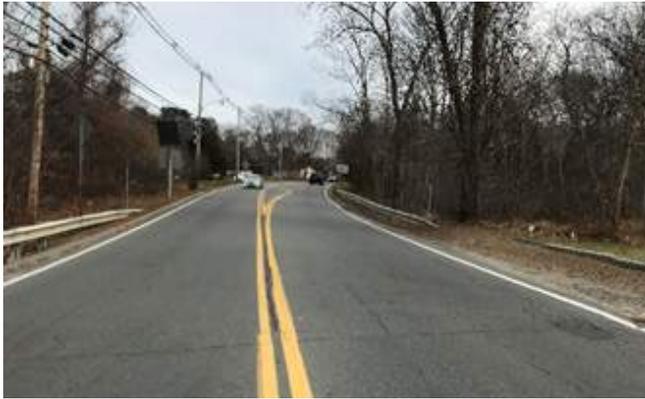
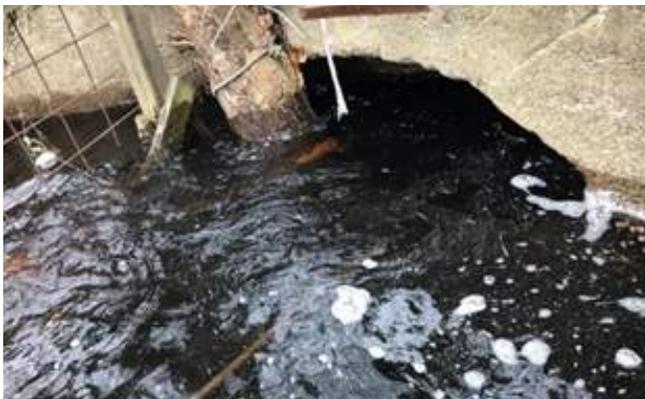
23. Haverhill Street over Batchelder Brook (312)

BRIDGE TYPE	Single culvert with HDPE pipe
WEARING SURFACE	Asphalt
RAILING TYPE	
UPSTREAM	Metal guardrail
DOWNSTREAM	Metal guardrail
OVERALL CONDITION	
NOTES:	Culvert completely submerged.
IMMEDIATE NEEDS	Re-inspect during lower flow period.

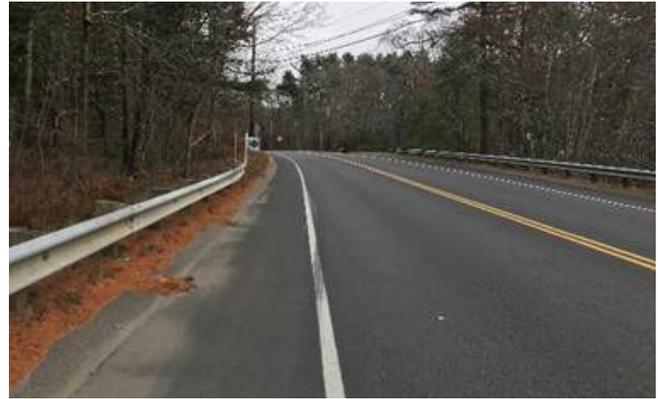
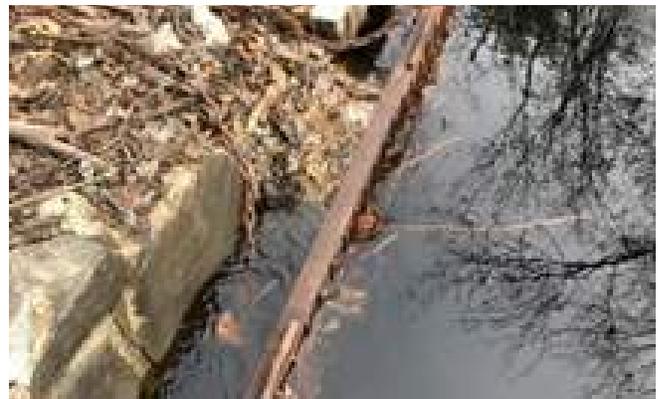
24. Haverhill Street (713)

BRIDGE TYPE	Single culvert with concrete
WEARING SURFACE	Asphalt
RAILING TYPE	
UPSTREAM	Metal guardrail
DOWNSTREAM	Metal guardrail
OVERALL CONDITION	5
NOTES:	Upstream pipe submerged in water, not visible. Mortared stone headwall is in a good condition. Downstream pipe is 90% full. Stone headwall has failed.
IMMEDIATE NEEDS	Repair downstream headwall.

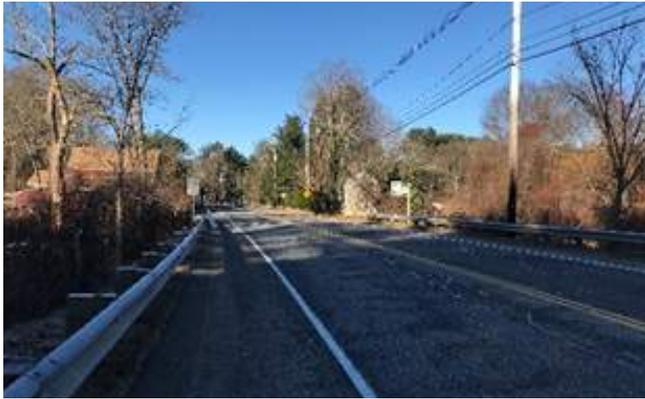
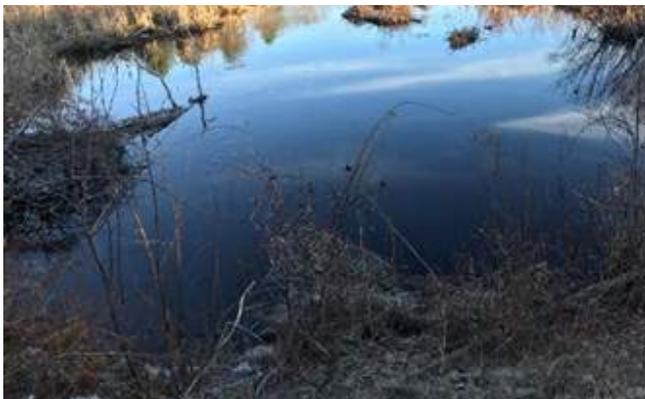
25. Haverhill Street over Mill River (851)

BRIDGE TYPE	TBD
WEARING SURFACE	Asphalt
RAILING TYPE	
UPSTREAM	Metal guardrail
DOWNSTREAM	Metal guardrail
OVERALL CONDITION	
NOTES:	Due to high water and heavy debris, culvert was not visible at either end.
IMMEDIATE NEEDS	Revisit culvert during period of low flow to better identify.

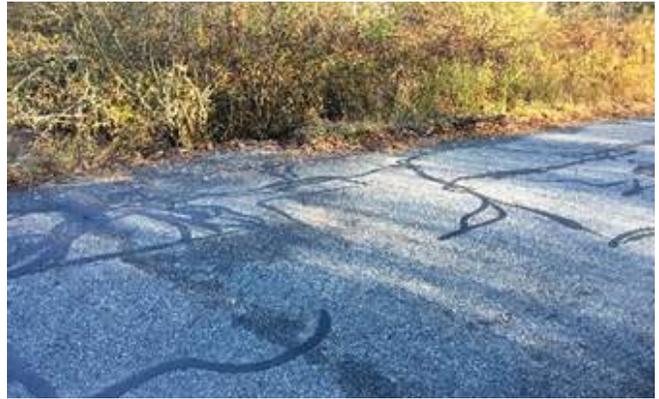
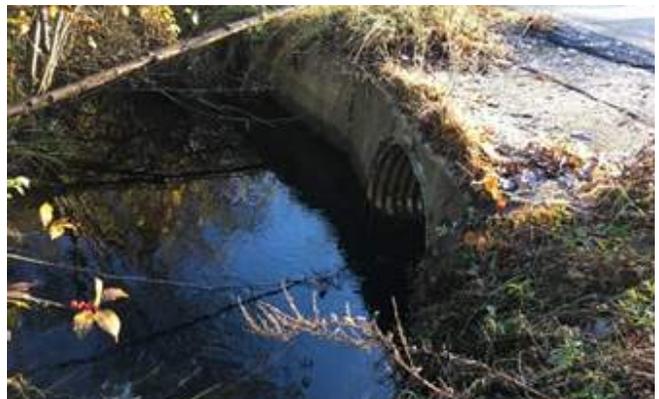
26. Hillside Street (60)

BRIDGE TYPE	Single culvert with metal pipe
WEARING SURFACE	Asphalt
RAILING TYPE	
UPSTREAM	None
DOWNSTREAM	None
OVERALL CONDITION	7
NOTES:	Concrete headwall and wingwalls at inlet. Masonry at outlet. Floods frequently.
IMMEDIATE NEEDS

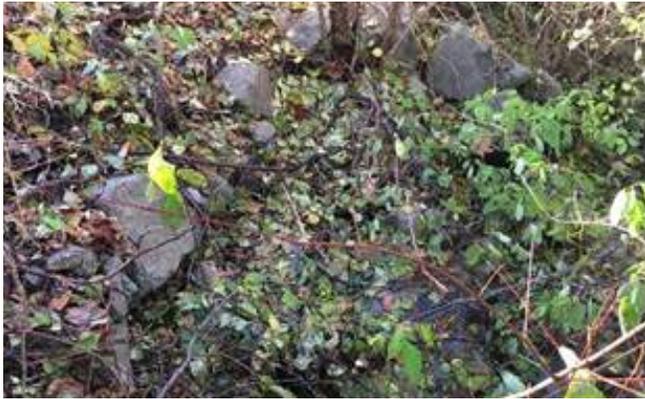
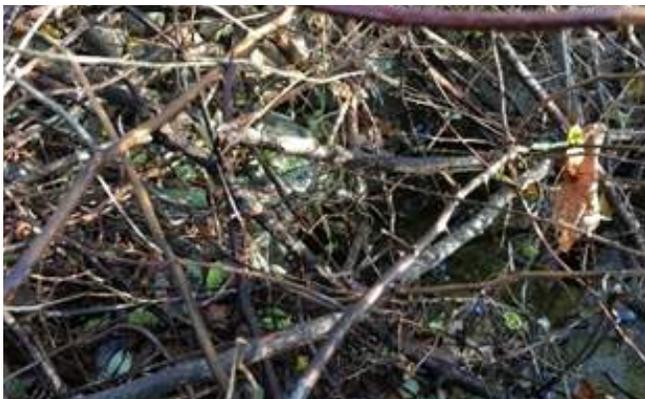
27. Hillside Street (170)

BRIDGE TYPE	Single culvert with pipe
WEARING SURFACE	Asphalt
RAILING TYPE	
UPSTREAM	None
DOWNSTREAM	None
OVERALL CONDITION	4

NOTES: Inlet and outlet headwalls have completely collapsed.

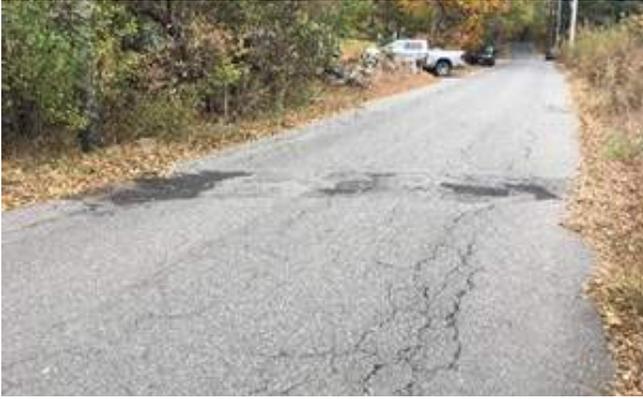
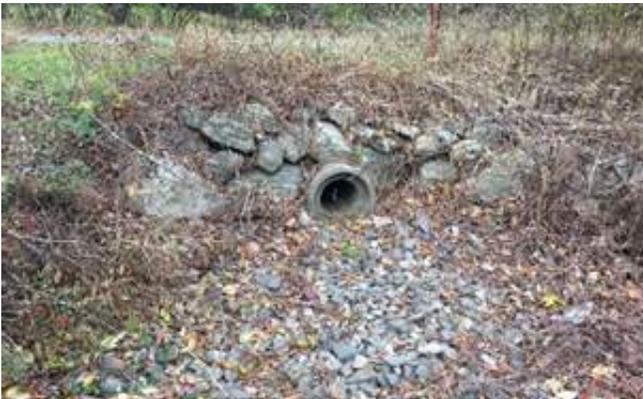
29. Newbury Road (164)

BRIDGE TYPE	Single culvert with concrete pipe
WEARING SURFACE	Asphalt
RAILING TYPE	
UPSTREAM	None
DOWNSTREAM	None
OVERALL CONDITION	7
NOTES:	Inlet is steel grate and drop inlet. Outlet to riprap apron and field. Asphalt on top is rutted and patched.
IMMEDIATE NEEDS

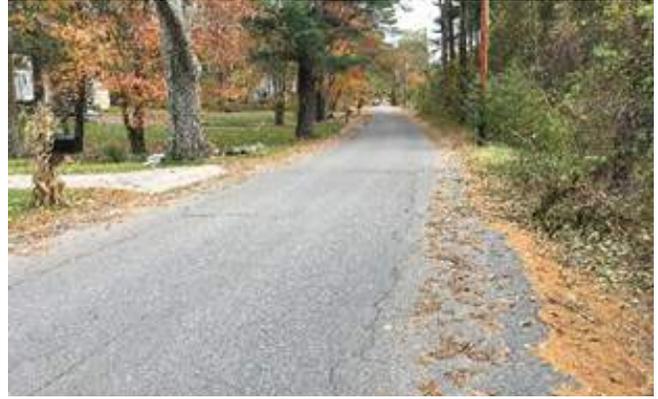
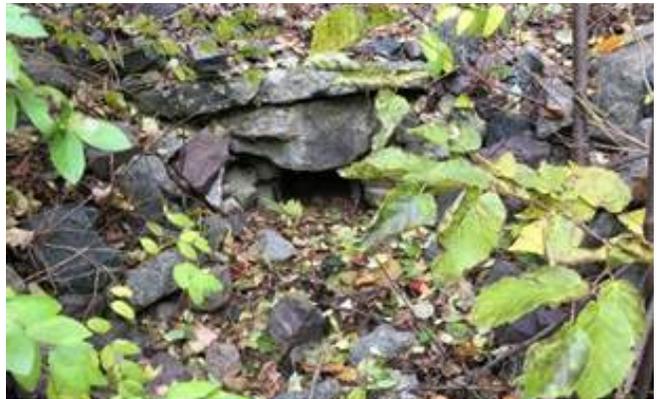
30. Newbury Road (204)

BRIDGE TYPE	Single culvert with metal pipe
WEARING SURFACE	Asphalt
RAILING TYPE	
UPSTREAM	None
DOWNSTREAM	None
OVERALL CONDITION	7
NOTES:	Un-grouted masonry headwall and wingwalls at inlet and outlet. (drying during field visit)
IMMEDIATE NEEDS

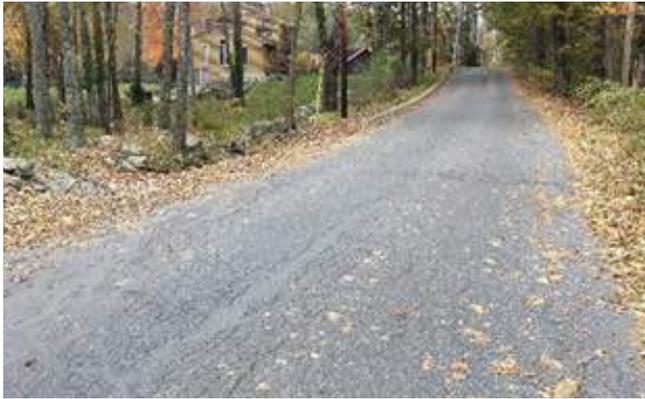
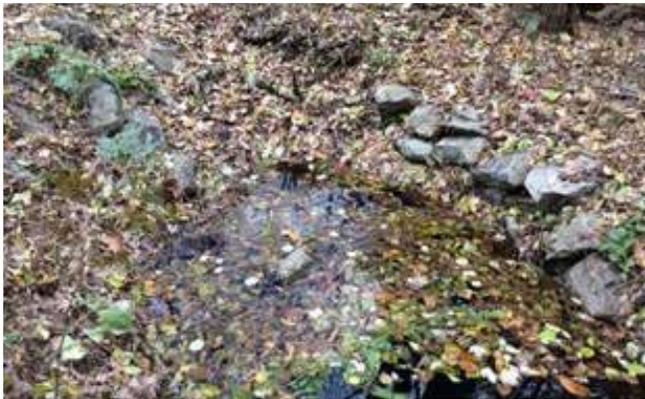
31. Newbury Road (259)

BRIDGE TYPE	Single culvert with metal pipe
WEARING SURFACE	Asphalt
RAILING TYPE	
UPSTREAM	None
DOWNSTREAM	None
OVERALL CONDITION	5
NOTES:	Inlet headwall is missing. Outlet headwall is not visible. Riprap slopes around outlet.
IMMEDIATE NEEDS	Uncover inlet and outlet.

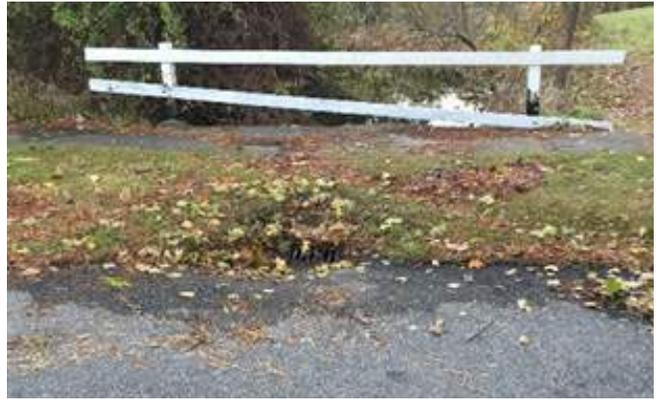
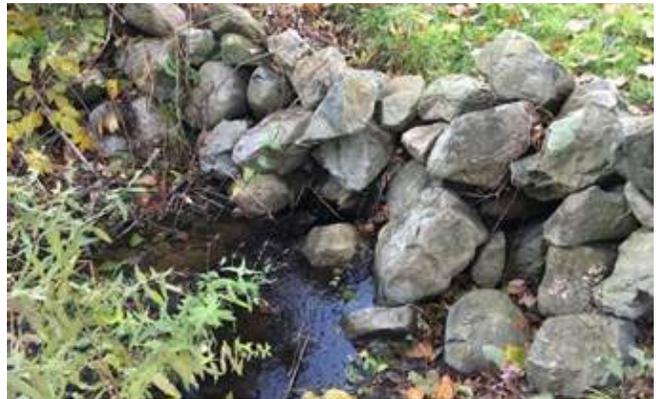
32. Pleasant Street (49)

BRIDGE TYPE	Single culvert
WEARING SURFACE	Asphalt
RAILING TYPE	
UPSTREAM	Wood
DOWNSTREAM	None
OVERALL CONDITION	5
NOTES:	Headwall at outlet has collapsed. Inlet is partially blocked with sediment.
IMMEDIATE NEEDS	Repair headwall and remove sediment.

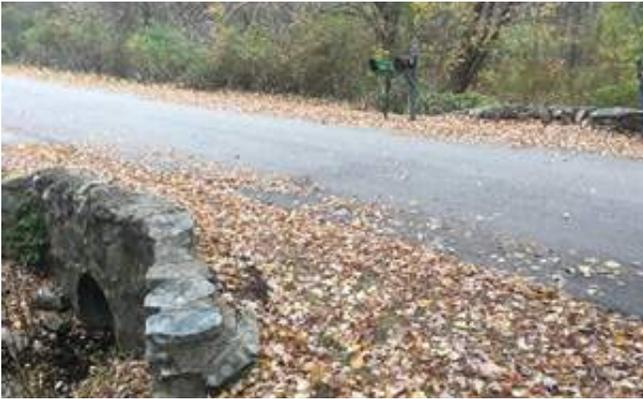
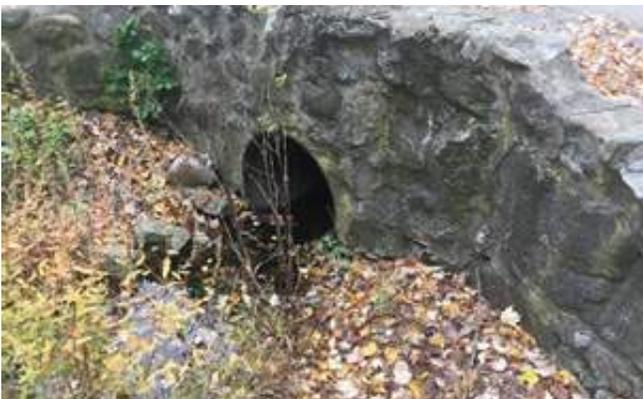
33. Prospect Street (35)

BRIDGE TYPE	Single culvert with concrete pipe
WEARING SURFACE	Asphalt
RAILING TYPE	
UPSTREAM	Low stone parapet
DOWNSTREAM	Low stone parapet
OVERALL CONDITION	8
NOTES:	Grouted masonry headwall and wings.
IMMEDIATE NEEDS

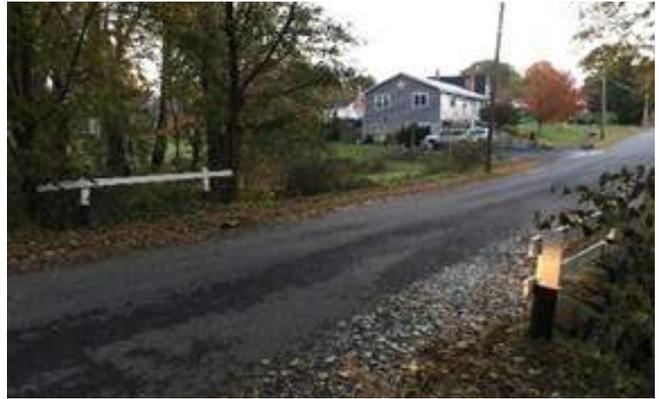
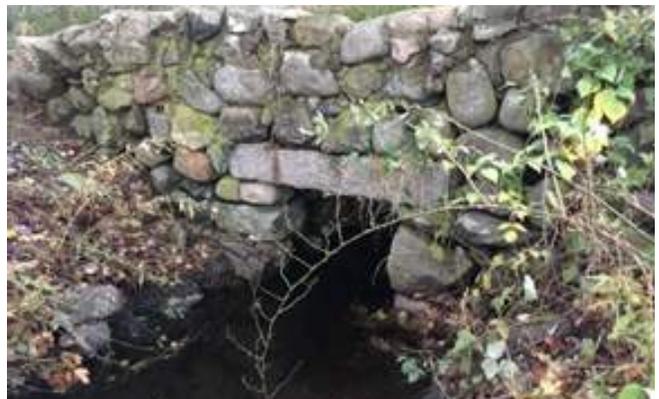
34. School Street (36)

BRIDGE TYPE	Single culvert with masonry/ concrete
WEARING SURFACE	Asphalt
RAILING TYPE	
UPSTREAM	Wood
DOWNSTREAM	Wood
OVERALL CONDITION	6
NOTES:	Headwall at inlet is leaning outwards. Some need of repointing. Cracks in asphalt.
IMMEDIATE NEEDS	Repair sidewalk, downstream side.

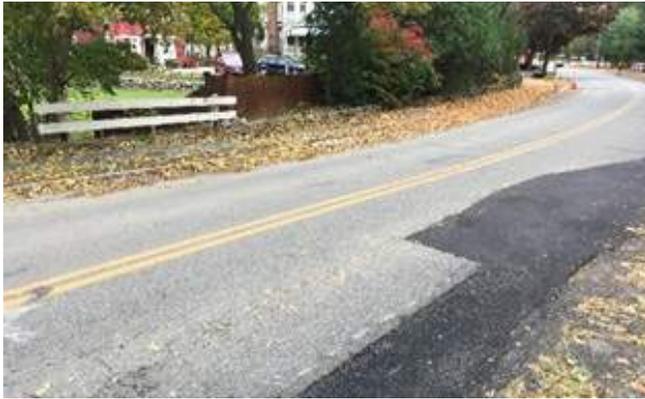
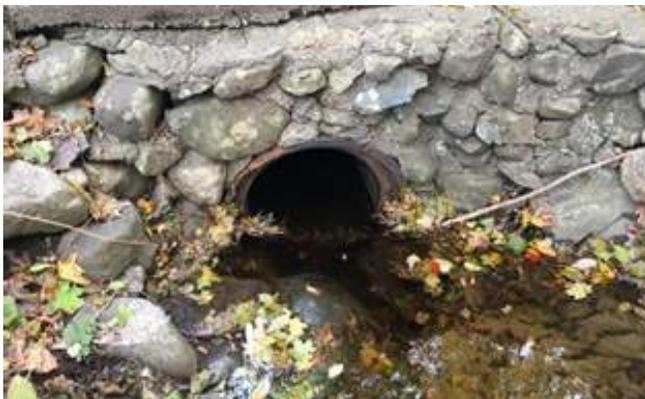
35. Summer Street (67)

BRIDGE TYPE	Single culvert with concrete/clay pipe
WEARING SURFACE	Asphalt
RAILING TYPE	
UPSTREAM	None
DOWNSTREAM	Wood
OVERALL CONDITION	7
NOTES:	Minor erosion appears behind inlet wingwall. Additional 15" dia. Conc. Pipe at outlet from nearby drop inlet.
IMMEDIATE NEEDS

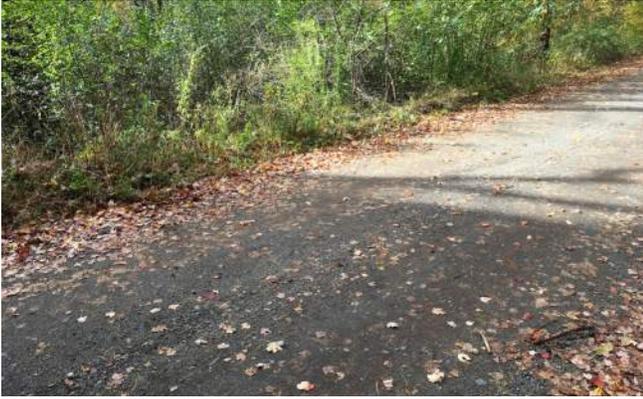
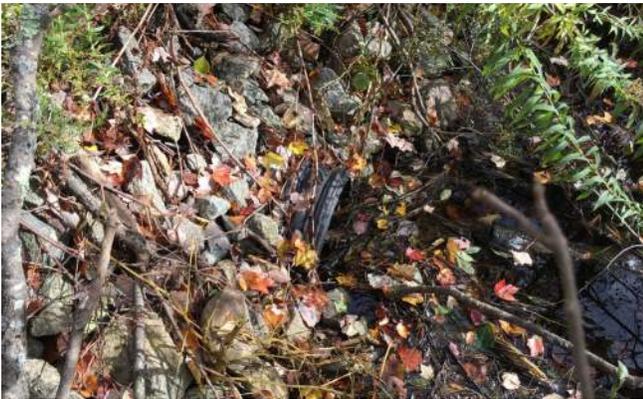
37. West Ox Pasture Ln. (45)

BRIDGE TYPE	Single culvert with poly pipe
WEARING SURFACE	Compacted Stone
RAILING TYPE	
UPSTREAM	None
DOWNSTREAM	None
OVERALL CONDITION	8
NOTES:	Recently installed structure. Riprap slopes.
IMMEDIATE NEEDS

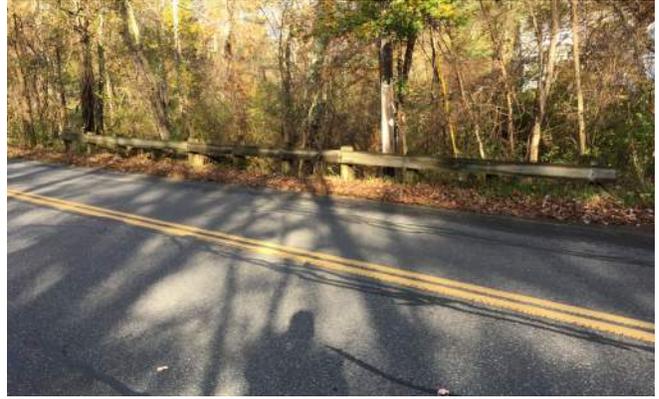
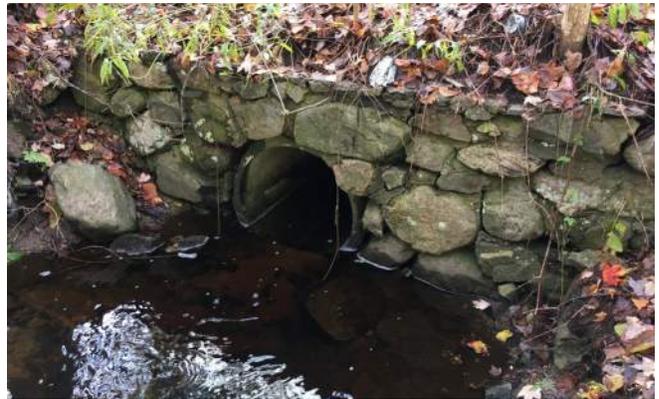
38. Wethersfield Street (256)

BRIDGE TYPE	Single culvert with concrete pipe
WEARING SURFACE	Asphalt
RAILING TYPE	
UPSTREAM	Wood guardrail
DOWNSTREAM	Wood guardrail
OVERALL CONDITION	5
NOTES:	No pointing at outlet. Dislodged stones at inlet headwall, no pointing.
IMMEDIATE NEEDS	Remove trees behind headwall; rebuild inlet headwall.

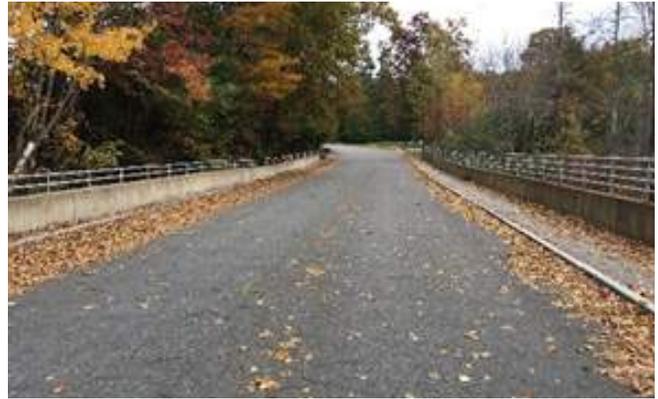
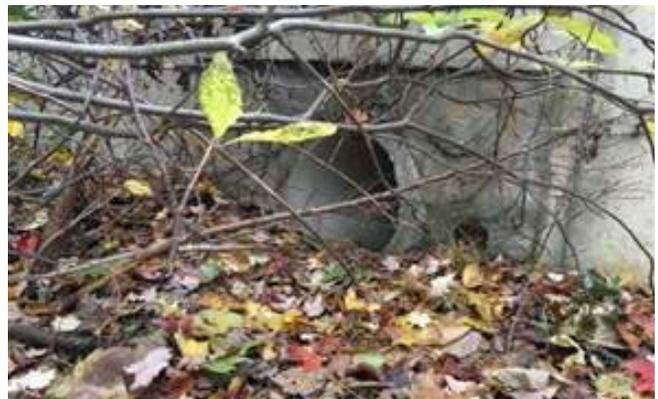
42. Wilkes Road (29)

BRIDGE TYPE	Double culvert with concrete pipe
WEARING SURFACE	Asphalt
RAILING TYPE	
UPSTREAM	Conc. Parapet with metal rail
DOWNSTREAM	Conc. Parapet with metal rail
OVERALL CONDITION	8
NOTES:	Pipes at base of back-to-back retaining walls are supporting road.
IMMEDIATE NEEDS

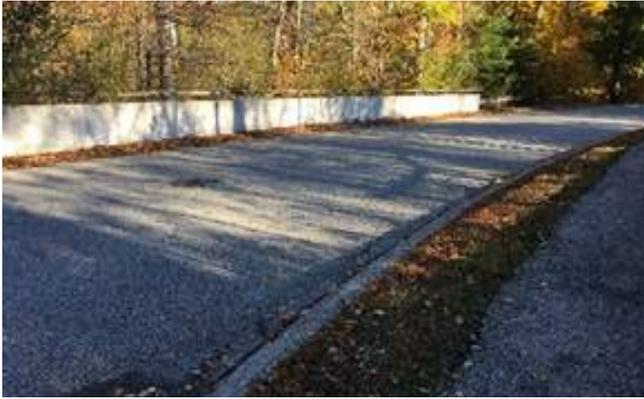
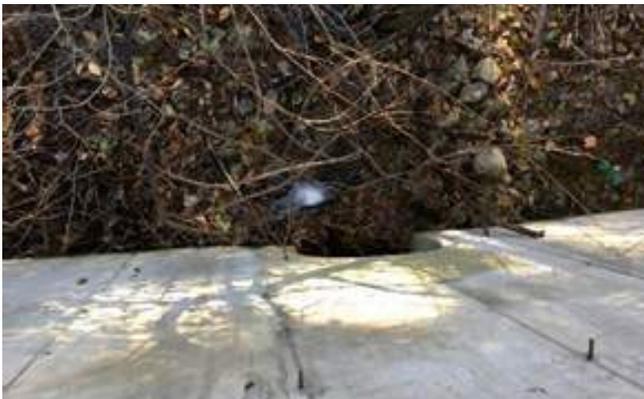
43. Spencer Knowles Road (28)

BRIDGE TYPE	Single culvert with concrete pipe
WEARING SURFACE	Asphalt
RAILING TYPE	
UPSTREAM	Conc. Parapet with metal rail
DOWNSTREAM	Conc. Parapet with metal rail
OVERALL CONDITION	8
NOTES:	Minor cracks appear in parapet.
IMMEDIATE NEEDS

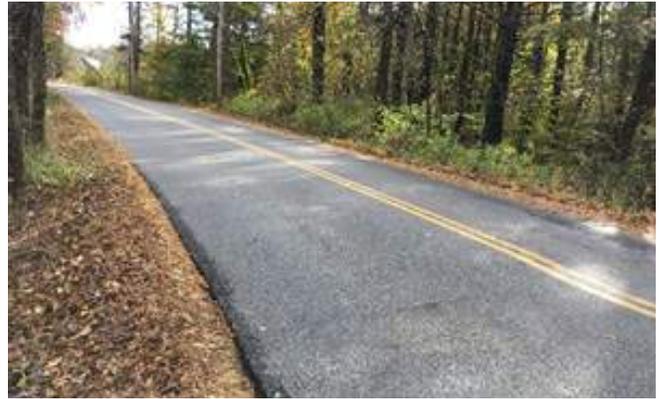
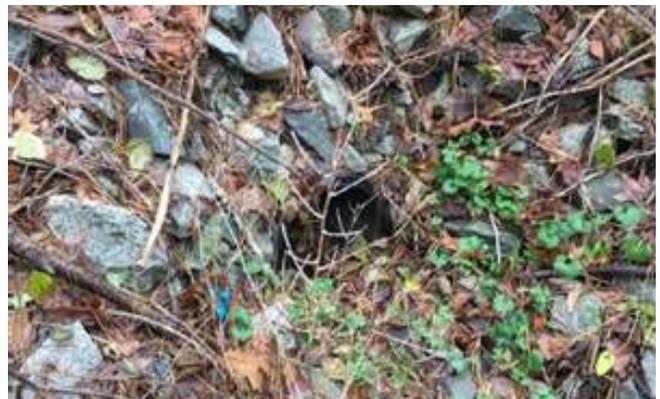
44. Wethersfield Street

BRIDGE TYPE	Single culvert with poly pipe
WEARING SURFACE	Asphalt
RAILING TYPE	
UPSTREAM	None
DOWNSTREAM	None
OVERALL CONDITION	6
NOTES:	Drains wetlands area. Dip in road over pipe. Un-grouted stones for headwall.
IMMEDIATE NEEDS

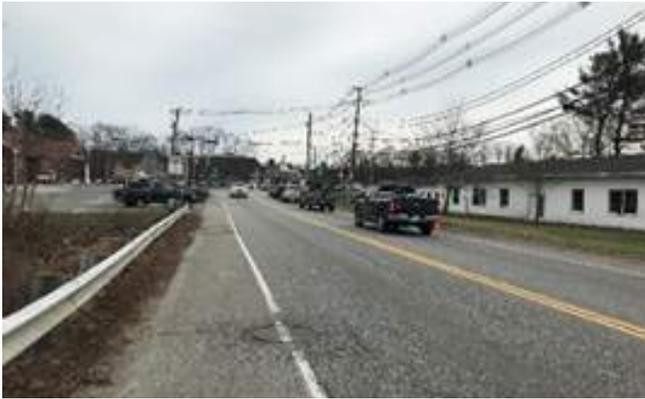
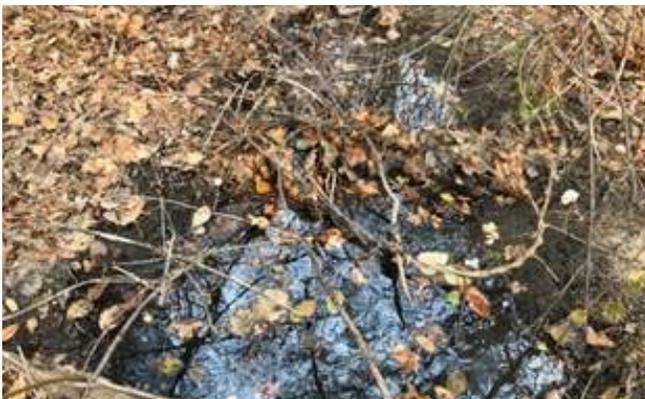
45. Haverhill Street (414)

BRIDGE TYPE	Single culvert
WEARING SURFACE	Asphalt
RAILING TYPE	
UPSTREAM	None
DOWNSTREAM	Metal guardrail
OVERALL CONDITION	6
NOTES:	Downstream (N) portal is submerged in water; headwall fair; upstream portal appears to be CB.
IMMEDIATE NEEDS	Clean DS channel.
